# Barrier (Rake) Is Not a Covered Footbridge

The History and Form of the Timber Floating Facility on the Example of the Ponholz Barrier in Blansko near Kaplice

*Jarmila Hansová*

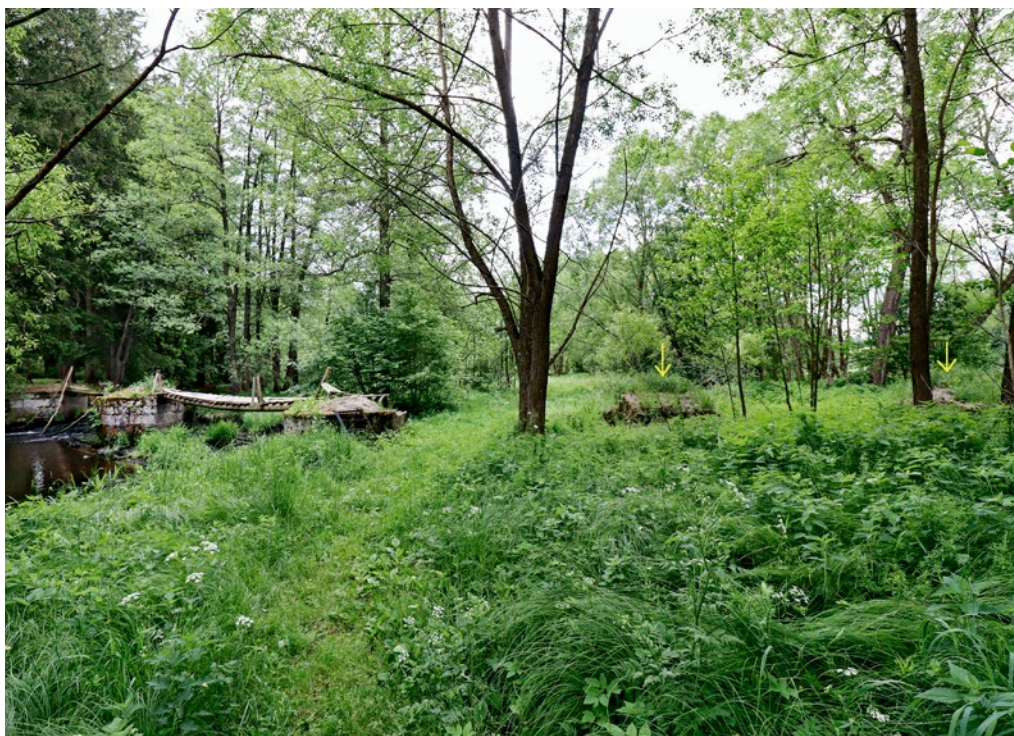
*Fig. 1. Blansko near Kaplice, the Ponholz barrier, general view upstream the River Černá, marking the land piers, photo: Marie Hansová, 2024*

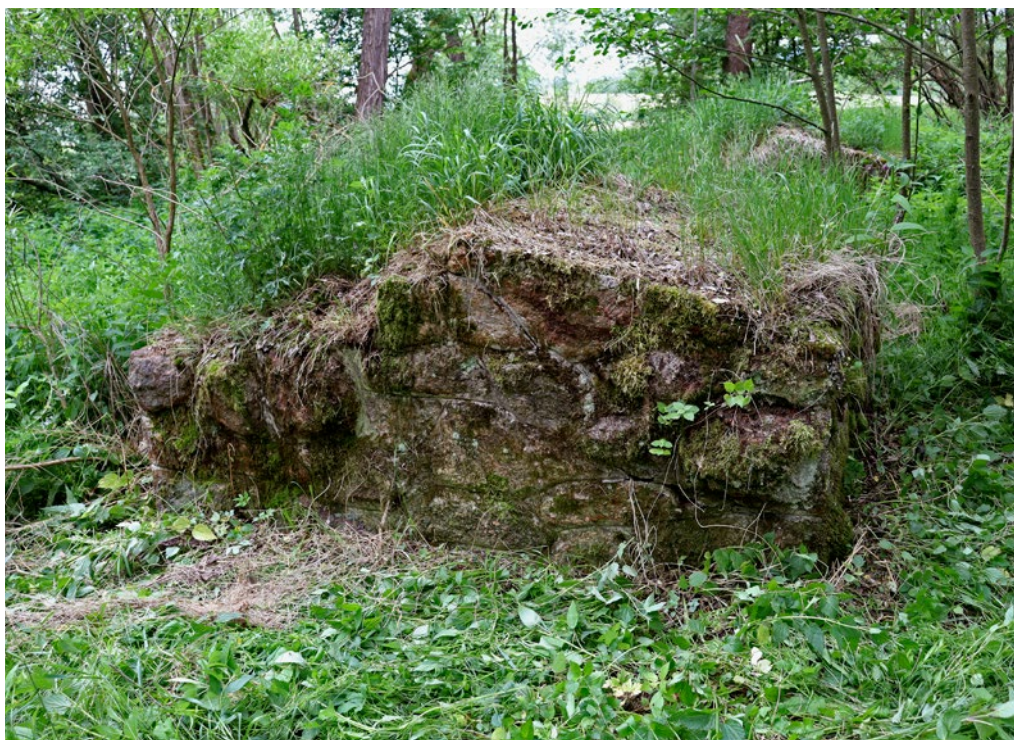
*Fig. 2. Blansko near Kaplice, the Ponholz barrier, the side of an uncovered land pier, with the fifth pier behind, photo: the author, 2024*

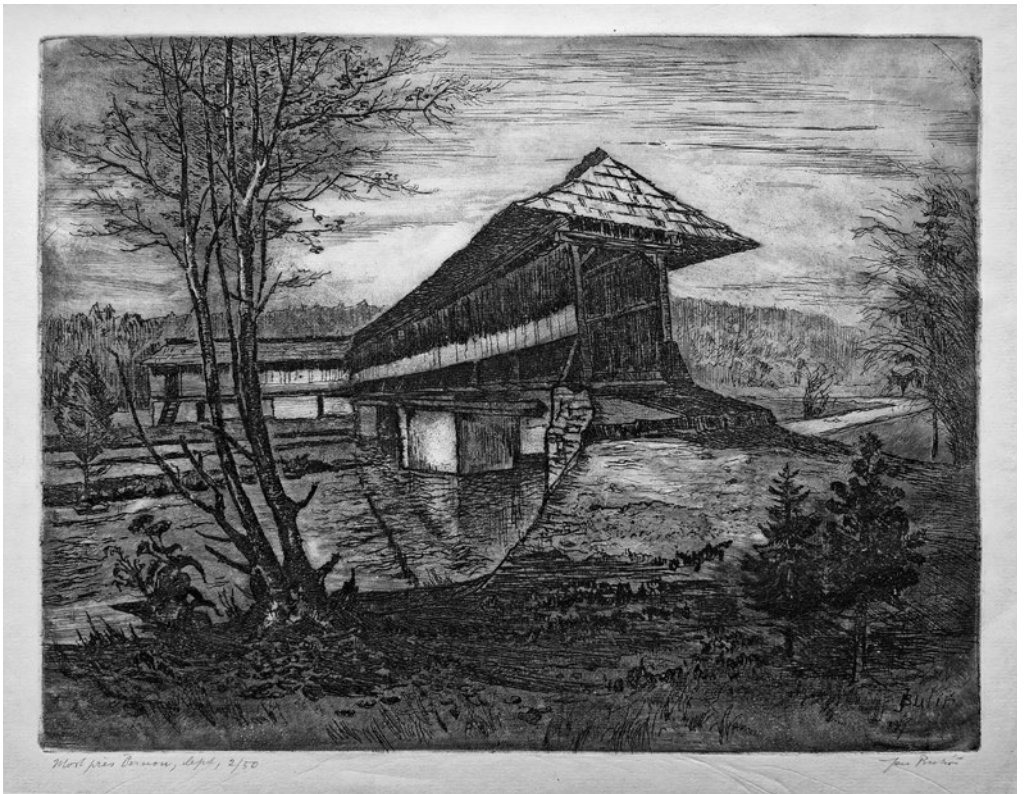
Fig. 3. Bridge spanning the River Černá, etching, Jan Bulíř, 1970s (?), source: private collection

It was the covered footbridges that made the barriers in Český Krumlov and Lenora noticeable at first glance. Furthermore, their fame was enhanced by their location in busy areas frequented by many people, both locals and tourists. Although their timber-floating history remained recognised, it was the wooden roof and timber casing that attracted the most attention. Apparently, this view of the barrier as a bridge that ‘always’ has a covered footbridge resonates with many locals and informed supporters of historical monuments.<sup>34</sup> Considering the numerous existing wooden covered bridges and footbridges that primarily served as transport structures, it was logical to integrate covered barriers among them, particularly emphasising their canopies.<sup>35</sup> Encyclopaedias of bridges and overviews of other monuments refer to them as wooden covered footbridges, known as barriers (rakes), whereas calling them barriers with wooden covered footbridges would be more precise given the purpose of these structures. It is interesting to note how the barrier in Blansko goes completely unnoticed, although it has recently also received a covered footbridge, so picturesque that it became the central motif of an etching by Jan Bulíř, a painter from České Budějovice (fig. 3). This is certainly due to its location in remote areas.

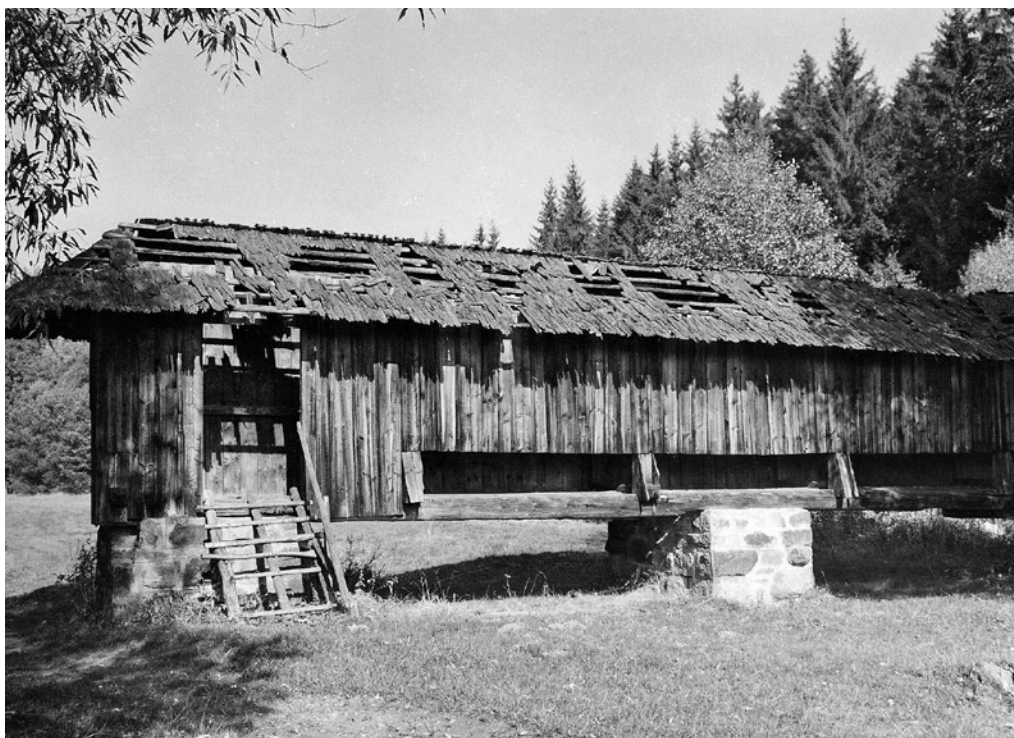
↑ *Fig. 4.* Blansko near Kaplice, the Pohnholz barrier, view from the right bank of the River Černá, photo: 1980, source: NPÚ, ÚOP in České Budějovice, collection of photographic documentation

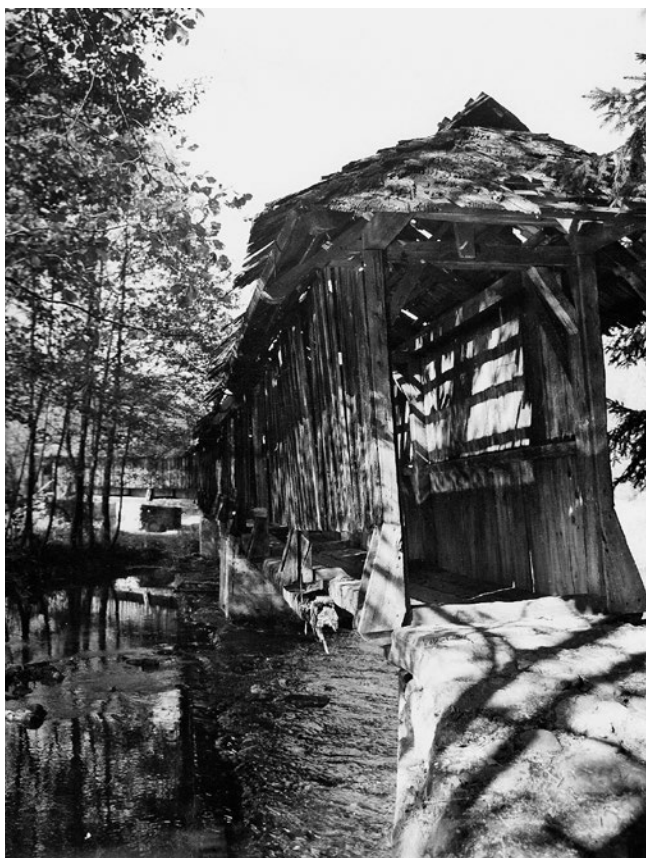
← *Fig. 5.* Blansko near Kaplice, the Pohnholz barrier, a part along the left bank of the River Černá, view downstream, photo: 1980, source: NPÚ, ÚOP in České Budějovice, collection of photographic documentation

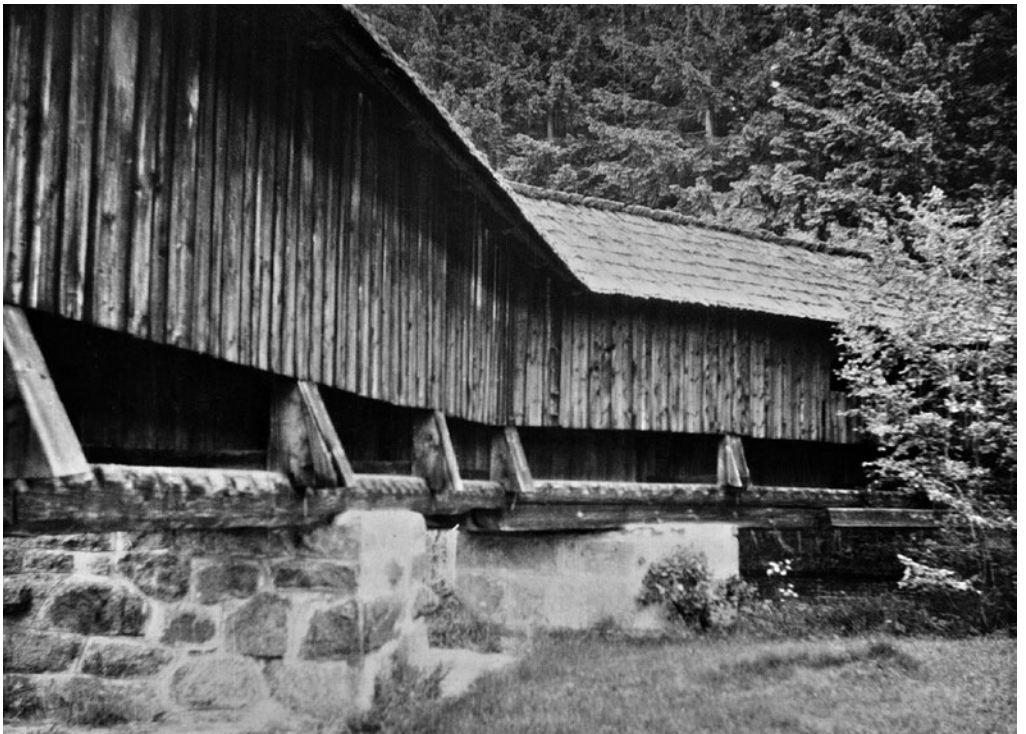
*Fig. 6.* Blansko near Kaplice, the Ponholz barrier, the front view reveals the mortises in the beam against which the bar screen bars were propped, photo: V. Šolc, 1955, source: Etnologický ústav AV ČR, v.v.i., photo documentation collection Prague, sign. 5958 HK

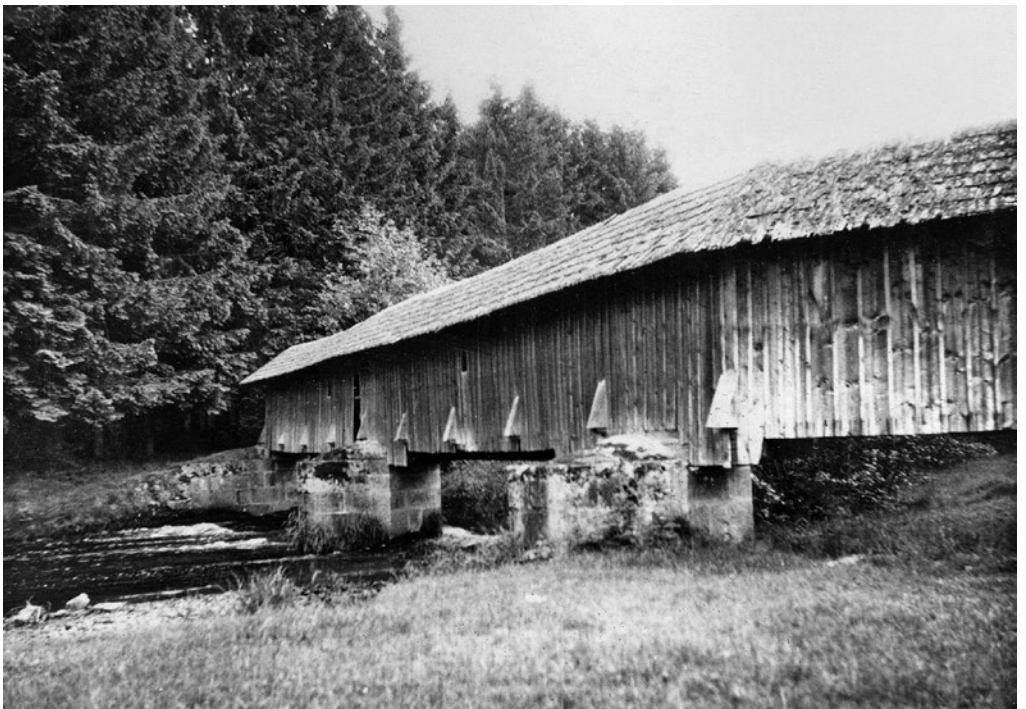
*Fig. 7.* Blansko near Kaplice, the Ponholz barrier, rear view, photo: V. Šolc, 1955, source: Etnologický ústav AV ČR, v.v.i., photo documentation collection Prague, sign. 5957a HK

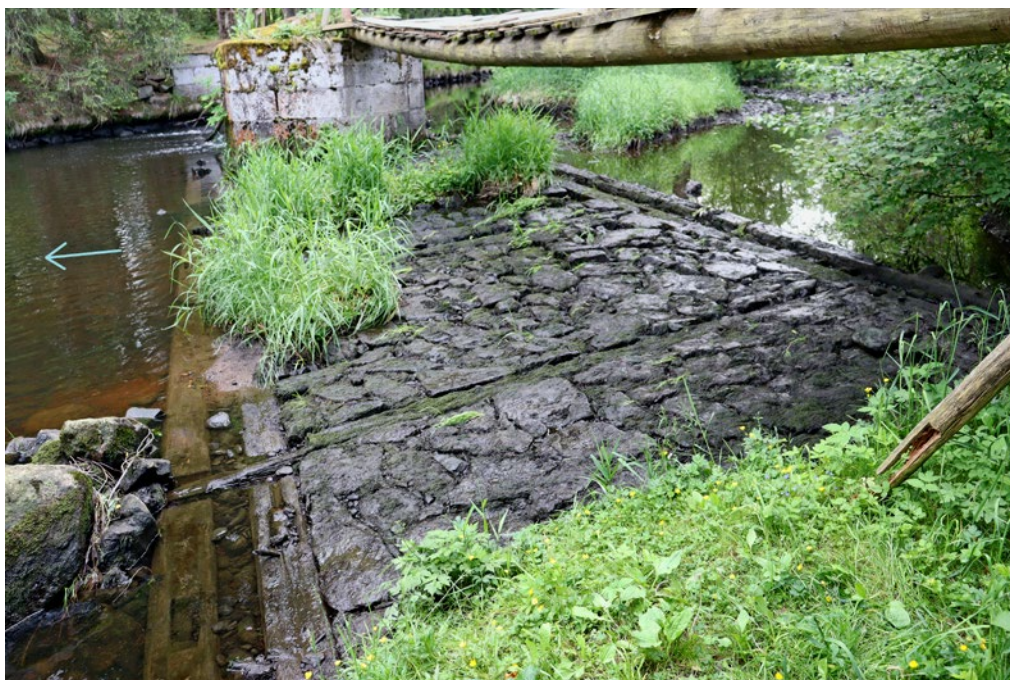
Fig. 8. Blansko near Kaplice, the Ponzholz barrier, the reinforced riverbed below the barrier, downstream direction, indicated flow direction, photo: Marie Hansová, 2024

beams positioned side by side and adequately embedded (see figs. 15 and 19).<sup>62</sup> The old photographs of the barriers in Český Krumlov (figs. 22 and 23), Hory (Spitzenberg, fig. 17), and the Vchynice-Tetov Canal (fig. 12) show the bars positioned almost perpendicularly. It was similar to the barriers in Lenora and Blansko. It is apparent from the placement of the groundsills in the riverbed almost directly under the beams against which the bar screens were propped and which allowed only a very small angle of the bars (see figs. 8 and 24).

Blansko near Kaplice (fig. 8). They could also be observed in the documented barrier in Lenora at low water levels and favourable light (see fig. 24); surprisingly, existing literature does not mention them at all.

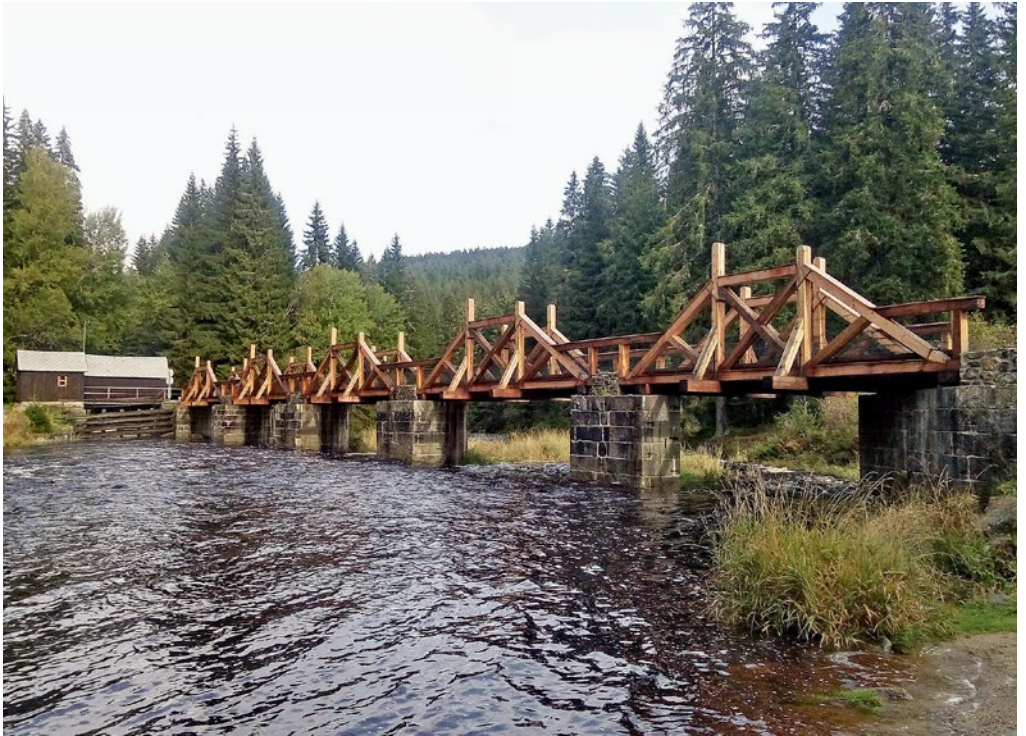
↑ Fig. 11. The barrier near Modrava at the beginning of the Vchynice-Tetov Canal with a footbridge replica built in 2000, photo: Zdeněk Kohlíček, 2012

However, the other preserved barriers, also designated as cultural monuments, are far from achieving the fame of the barriers in Lenora and Český Krumlov. Although the rake bridge on the River Vydra, located at the beginning of the Vchynice-Tetov Canal, is a significant technical structure measuring 72 metres that was designed by Josef Rosenauer along with the navigational canal during 1799–1801, its construction seems to have never attracted much professional interest.<sup>31</sup> This is probably due to its long-lasting deterioration during the second half of the 20th century when its wooden construction disappeared. Not even after its replica was made in 2000 did this barrier capture the attention of the professional public<sup>32</sup> or popular science literature<sup>33</sup> despite the designation of the Vchynice-Tetov Canal as a national cultural monument in 2014. Similarly, the barrier in Plav, a unique example of technology (as described below), is not included in professional or popular science literature.

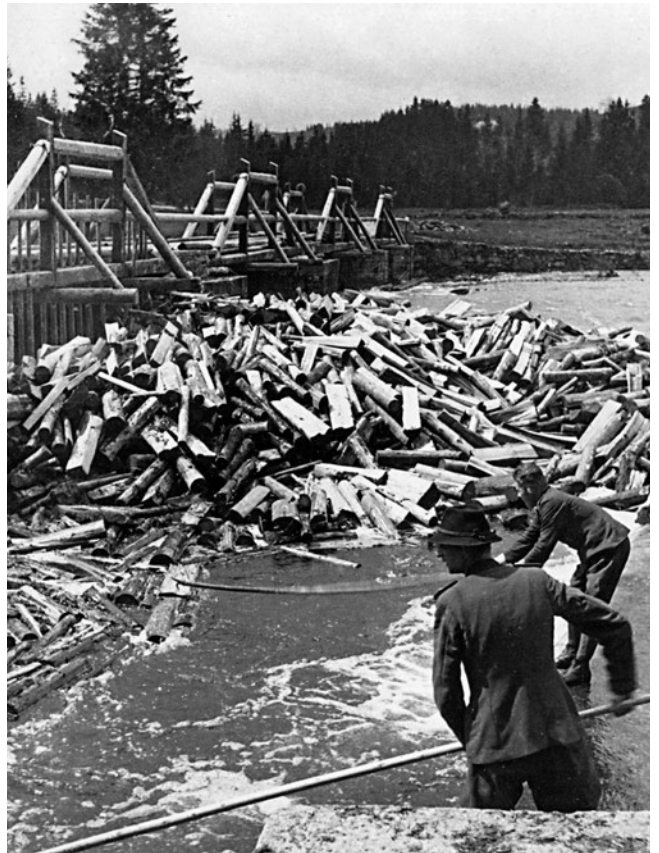
→ Fig. 12. The barrier near Modrava at the beginning of the Vchynice-Tetov Canal during timber floating, no date, source: ROUČKA, Zdeněk, *Předválečnou Šumavou. Život – práce – krajina*, Plzeň 2006, p. 106

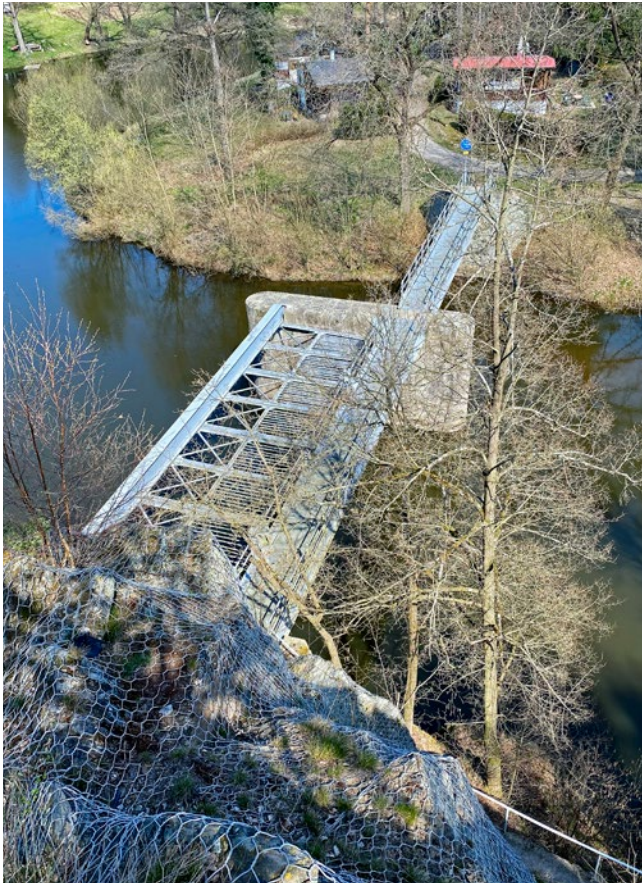
Fig. 13. Plav, a modern barrier from 1896, photo: Zdeňka Kočková, 2020

13795/3-1217). A modernised ‘weir basin’, referred to as a ‘barrier’ (no. ÚSKP 102466), stands out on the Malše in Plav (České Budějovice District). On the River Vydra in Šumava near Modrava, timber was directed into an artificial canal by a barrier or a rake (*hrablový*) bridge which is inaccurately stated as a (sluice) *hradlový* bridge, which is part of the Vchynice-Tetov Canal (no. ÚSKP 26816/4-3299, designated a national cultural monument in 2014).

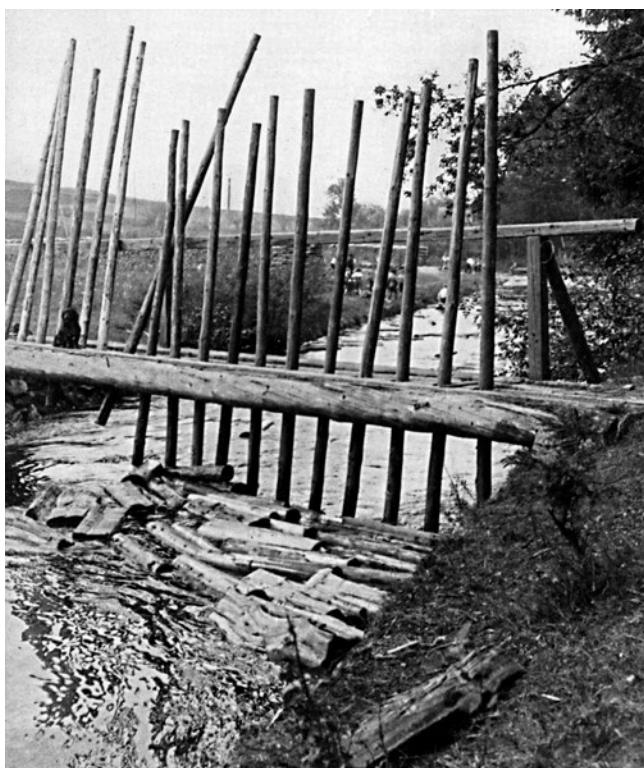
← Fig. 16. A simple barrier with a bar screen inserted through the openings drilled into the beam of the Vchynice-Tetov Canal, source: ROUČKA, Zdeněk, *Předválečnou Šumavou. Život – práce – krajina*, Plzeň 2006, p. 110

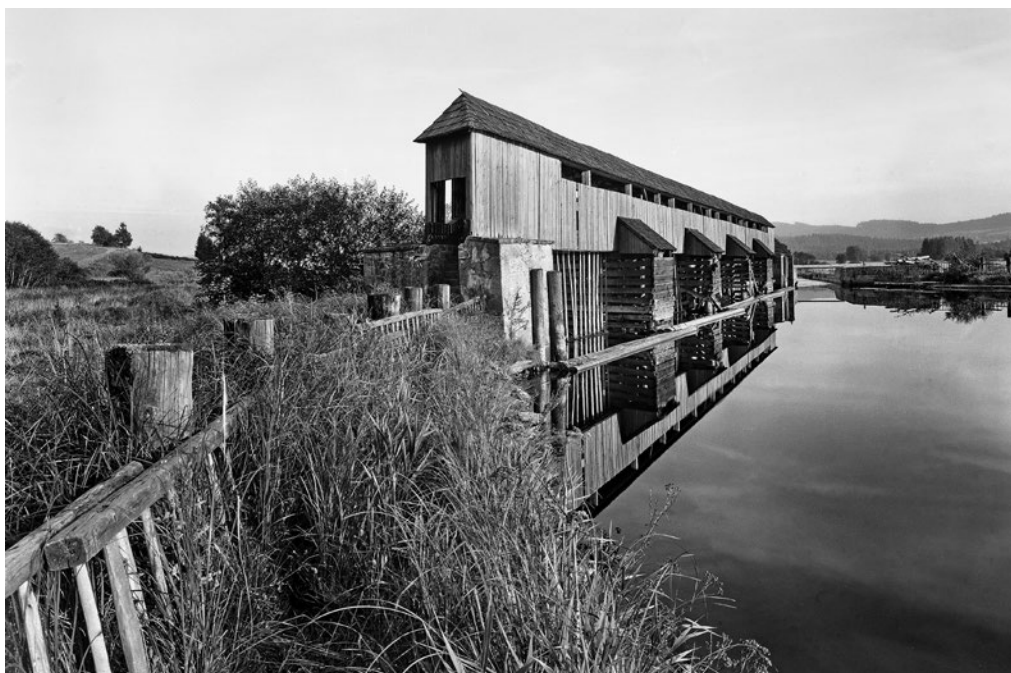
Fig. 17. The Spitzenberg (Hory) barrier on the Vltava near Želnavá, photo: Vladimír Hyhlík a Věra Pospíšilová, 1953, source: NPÚ Photo Archives, GnŘ, collection of photographic documentation

In the documented barriers in South Bohemia, a different method was employed to attach the bar screen to the beam. In the Blansko barrier, the bars leaned against the outer beam, which had mortises carved into it, as shown in the photograph from 1955 (see fig. 6). The same solution was applied to the barrier in Hory (Spitzenberg), but the beam supporting the bar screen was installed inside the covered footbridge.

To reduce the pressure from floating timber, a large, dried spruce trunk (*Schwimmer*) was placed in front of the bar screen.<sup>66</sup> The positioning of the floating beams in front of the bar screen to prevent the logs from slipping through the bars is shown in the photograph of the barrier at Hory (Spitzenberg) near Želnavá (fig. 17). In 1926, Jan Kolář described a similar component at the barrier at the beginning of the Vchynice-Tetov Canal: 'Massive octangular beams float in front of the bar screen, tied to chains and preventing the logs from penetrating into the watercourse through the space below the bar screen. The beams have a considerable draught, which can be increased by placing two beams on top of each other. The position of the bridge, and hence the area of the bar screen, ensures that the logs are driven by the beams into the canal mouth. The bar screen is constructed of spruce bars from resilient trees growing in the shade, spaced 40 cm apart and about 8 cm wide at their narrower ends. The device is so efficient that the bar screen can capture plenty of logs accumulated, even during the largest floods.'<sup>67</sup> Nonetheless, even this barrier did not withstand everything. Based

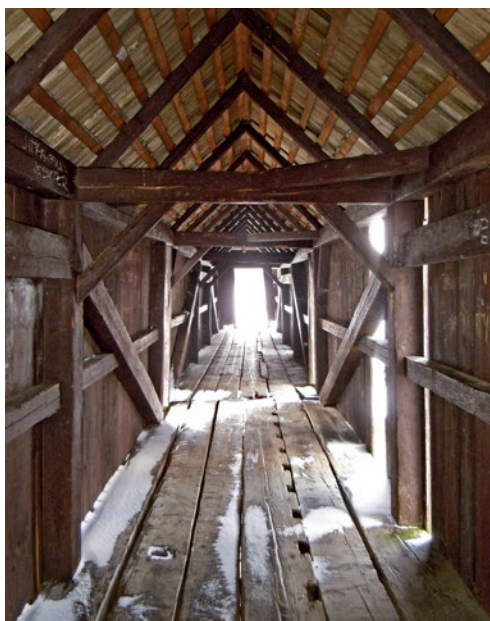
Fig. 21. Lenora, the Vogelberg barrier interior, state before the last repair (2012–2013), the beams were repositioned during previous repairs (e.g. in 1985), the beam with mortises has been dated to the 1860s by dendrochronology, photo: Radek Liška, 2012

This modified beam remains part of the footbridge deck in Lenora, which must now be considered a rare surviving element. Although it has not persisted in the Český Krumlov barrier following numerous repairs of the footbridge, it is depicted in a postcard from 1908. The neighbouring beam, again with carved mortises, which allowed smoother manipulation of the bar screen bars, is noteworthy. It remains unclear whether this beam was a fixed or removable part of the footbridge. Existing literature, after all, pays no attention to practical questions related to the bar screen fitting. The photograph of the Český Krumlov barrier interior evidently dates from a period without timber floating. This is substantiated by the low water level, as depicted in a postcard from the same series and year, as well as the large gaps between the bar screen bars. The question of why there were any bars left at all remains unanswered.

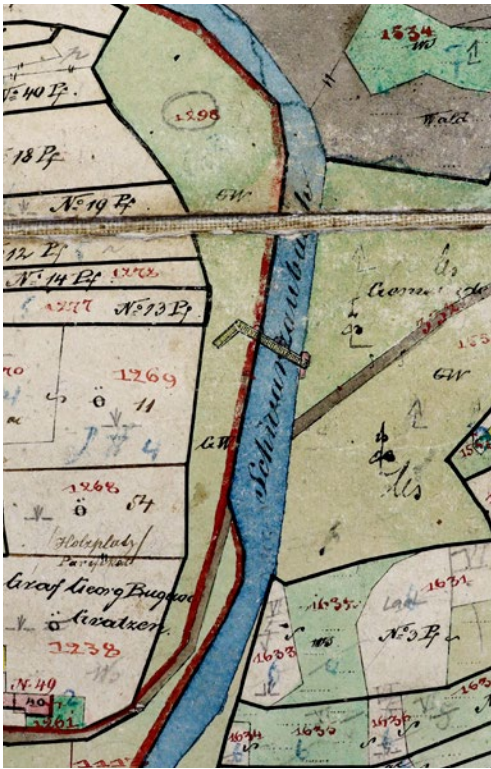
Fig. 30. The Ponholz barrier on the re-ambulated Map of the Stable Cadastre of Blansko near Kaplice, 1872, plotted in today's size, after 1904 extended by the riverbank section, source: Katastrální úřad pro Jihočeský kraj, katastrální pracoviště Český Krumlov
